# Operating experience with a generator stator end-winding vibration monitoring system

This paper presents the system to measure, display, evaluate and store stator end-winding vibration measurements for predictive maintenance in order to improve the economic performance of power plants. It describes installation procedure and operation experience of the system on four identical generators at the Beznau nuclear power plant in Switzerland.

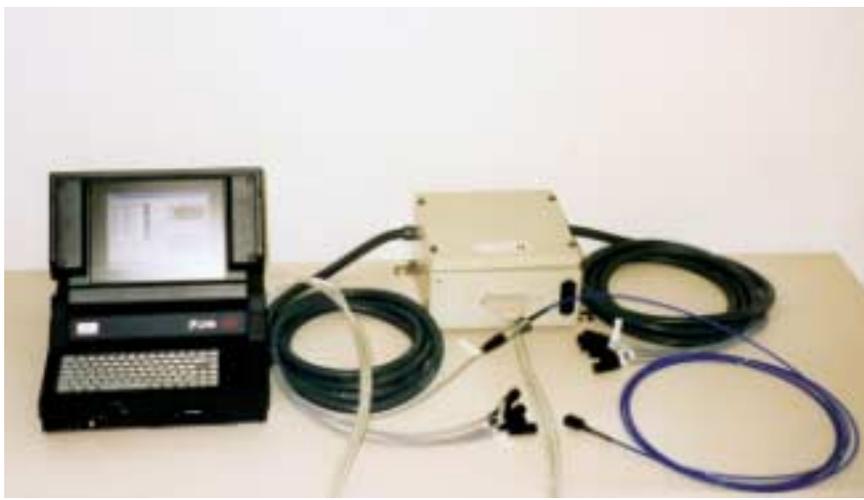
*Fig. 1: Fibre Optic Measuring System*

The fibre optic system as shown in Fig. 1 consists of fibre optic accelerometers and cables, power supply and a computer. Such a system can be installed on generators in about seven days during an overhaul. Usually, twelve (12) accelerometers are installed per turbo-generator, six (6) sensors on each side. Sensors are required for each group of phases in radial and/or tangential directions. On pump generating sets, large generators, and depending on winding design six (6) to twelve (12) or more accelerometers may be necessary. Current experiences on hydro generator propose radial measurement points at the exit of the bar from the laminations and tangential measurement points at the bar solder links.

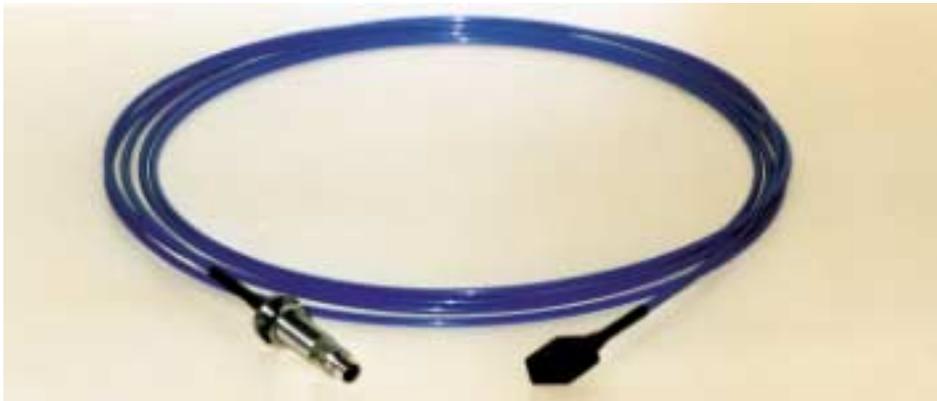
A typical fibre optic accelerometer is shown in Fig. 2. Its unibody design consist of a small size sensor head of non-conducting material, a fibre optic cable, and a feedthrough connector with built-in optoelectronic circuitry. It is sensitive to vibration in a single axis. The sensor head is located at the end of a two-strand, multimode, optical fibreglass cable. One fibre carries the light generated by the conditioning electronics for illumination; the sensor head returns an optical signal of variable intensity through the second fibre. The electrical isolation of the optical circuit allows the sensor to be mounted directly to the stator coil ends.

*Fig. 2: Fibre Optic Accelerometer with feedthrough conditioner*

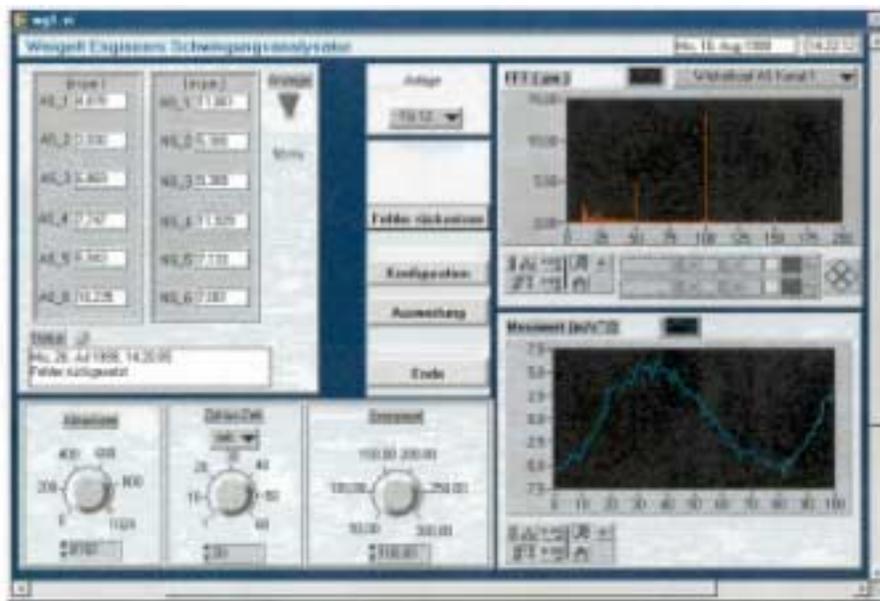
In the conditioning electronics, the optical signal is converted to an electrical signal by optoelectronic circuitry, processed and amplified to an acceptable level. The resultant measured signal is a calibrated analogue signal of 100 mV/g proportional to vibration acceleration which can be further processed by a computer. A specially designed software provides signal processing, display and data storage. In addition, vibration velocity and displacement are processed. After Fast Fourier Transform (FFT), the measured signals are displayed as amplitude-frequency spectrum (Fig. 3). The system can be used in stand-alone operation or linked to plant control system.

Fig. 3: Overview of software user interface

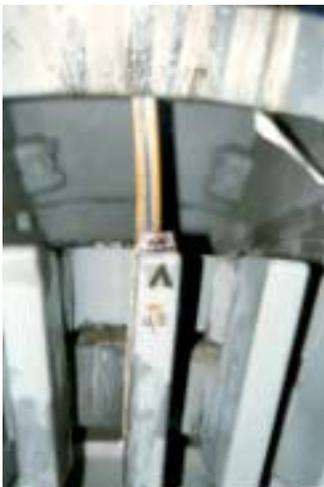
The fibre optic accelerometers are used for vibration measurements where conventional accelerometers are precluded. As previously mentioned, the accelerometer is sensitive in only one direction. Consequently, it is possible to monitor vibration of an installation in radial, axial and tangential directions. Fig. 4 shows how accelerometers and cables are installed on the end-windings. It is important to respect the minimum bending radius of the optical cable to avoid breaking. It is also important to mention that the feedthrough units must be equipped with O-rings withstanding the hydrogen environment of the generator and must be mounted on a flange (Fig. 5). The electrical signals are available at the feedthrough conditioning unit.

Fig. 4: Installed fibre optic accelerometer for radial measurement

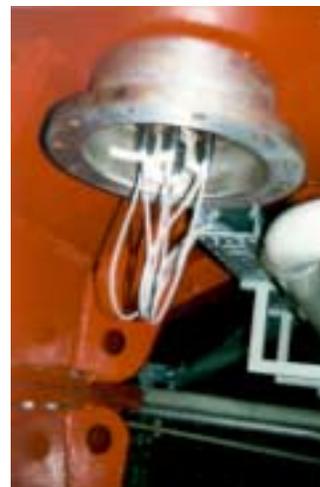
Fig. 5: Sealed flange with six feedthrough conditioners and cable

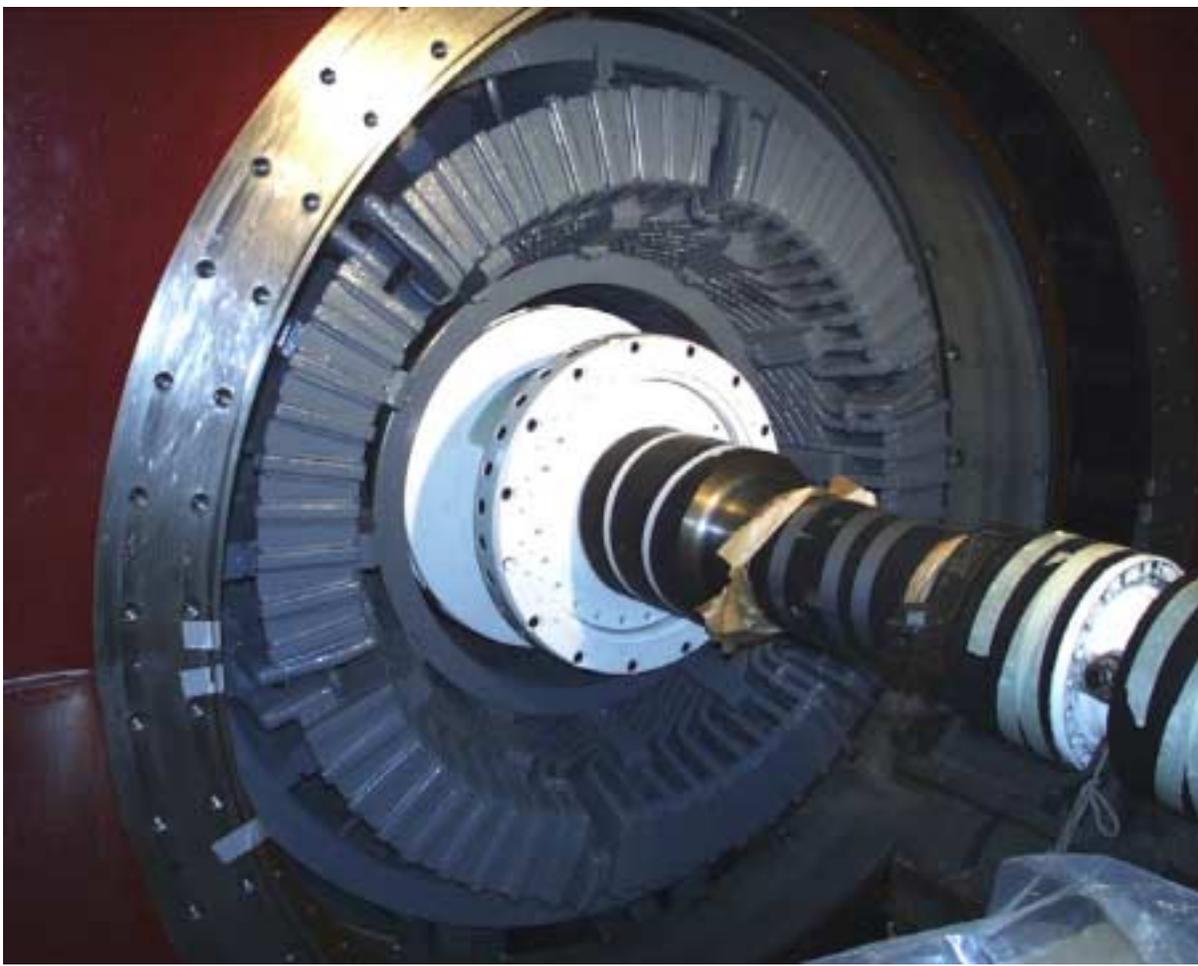
A total of four two-pole generators, each rated at 228 MVA with stator voltage of 15.5 kV, are installed. The rotor and stator windings are hydrogen cooled (Fig. 7). Each turboset has accumulated more than 200'000 operating hours. Normally, inspections are done in the summer when power demand is ensured by NOK hydro power plants.

*Fig. 7: Hydrogen-cooled two pole generator (228 MVA and 15,5 KV stator voltage)*

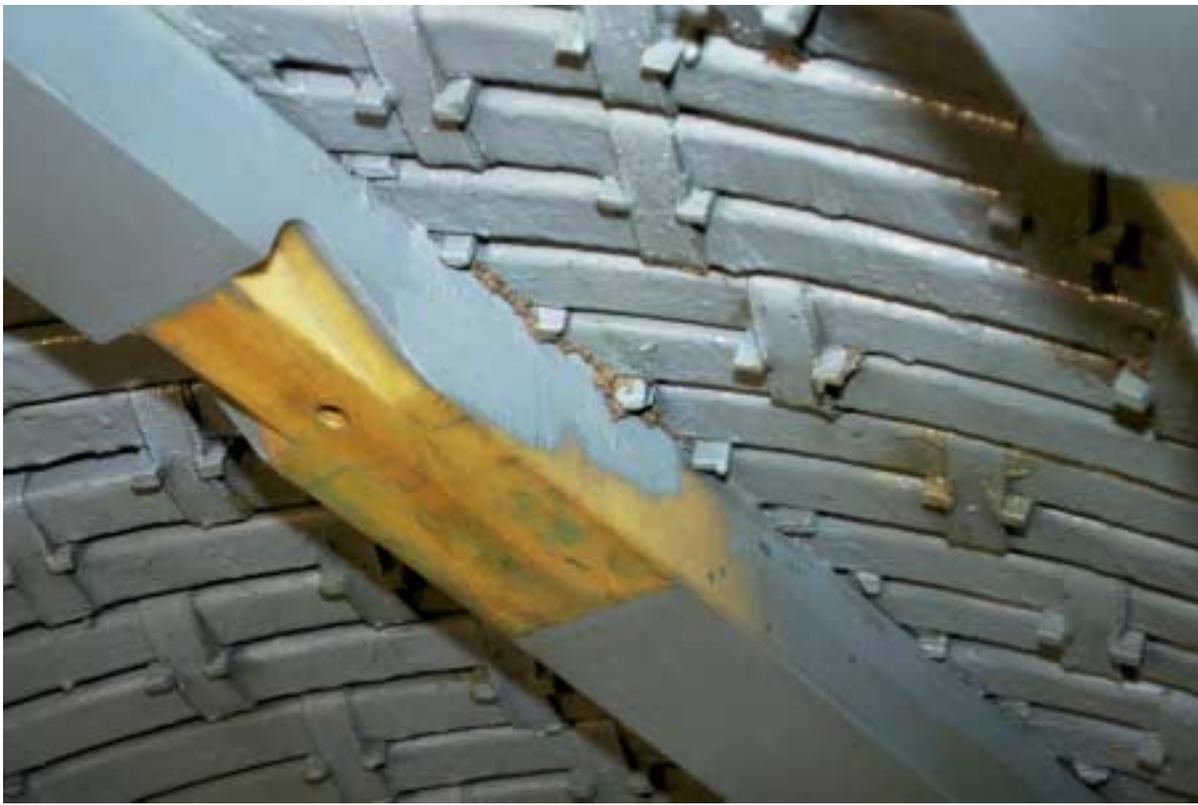
Insulation abrasion of the stator end-windings was always observed (Fig. 8) on past overhaul and maintenance shutdowns of the turbosets TG11, TG12, TG21 and TG22. In view of planning future overhauls and reliable power plant operations for the next 20 to 30 years, NOK decided to monitor the effective end-winding vibration and take corrective actions from this baseline.

*Fig. 8: Insulation abrasion between end-winding support elements*

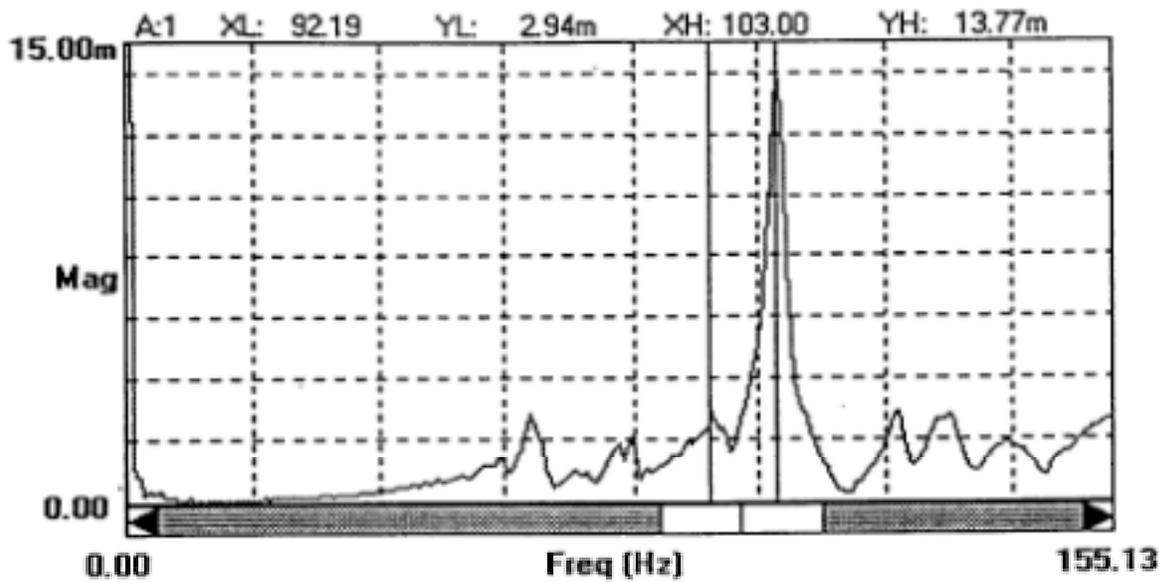
It shall be understood that the measures described herein are limited to the four generators. In order to determine the reasons for the end-winding insulation abrasion, the manufacturer conducted dynamic structural tests in 1992 and 1994. The results showed that the resonance frequency of the four node mode was slightly above 100 Hz with a high dynamic compliance in the tangential direction (Fig. 9)

*Fig. 9: End-winding resonance at 103 Hz at the driven-end*

The vibration analysis of each generator was done at the time of an overhaul shutdown at room temperature. At the non-driven end, the end-winding stiffness was higher compared to the driven end because of the lead bars and the parallel rings.

As end-winding temperature increases under continuous operation, a reduction of resonance frequency by a few Hertz is expected. In such case, the reduced resonance frequency of the four node mode could match the 100 Hz excitation force and amplify the vibration. With the high compliance of the end-windings in the tangential direction, high vibration amplitudes are expected, as the observed insulation abrasion had already well confirmed.

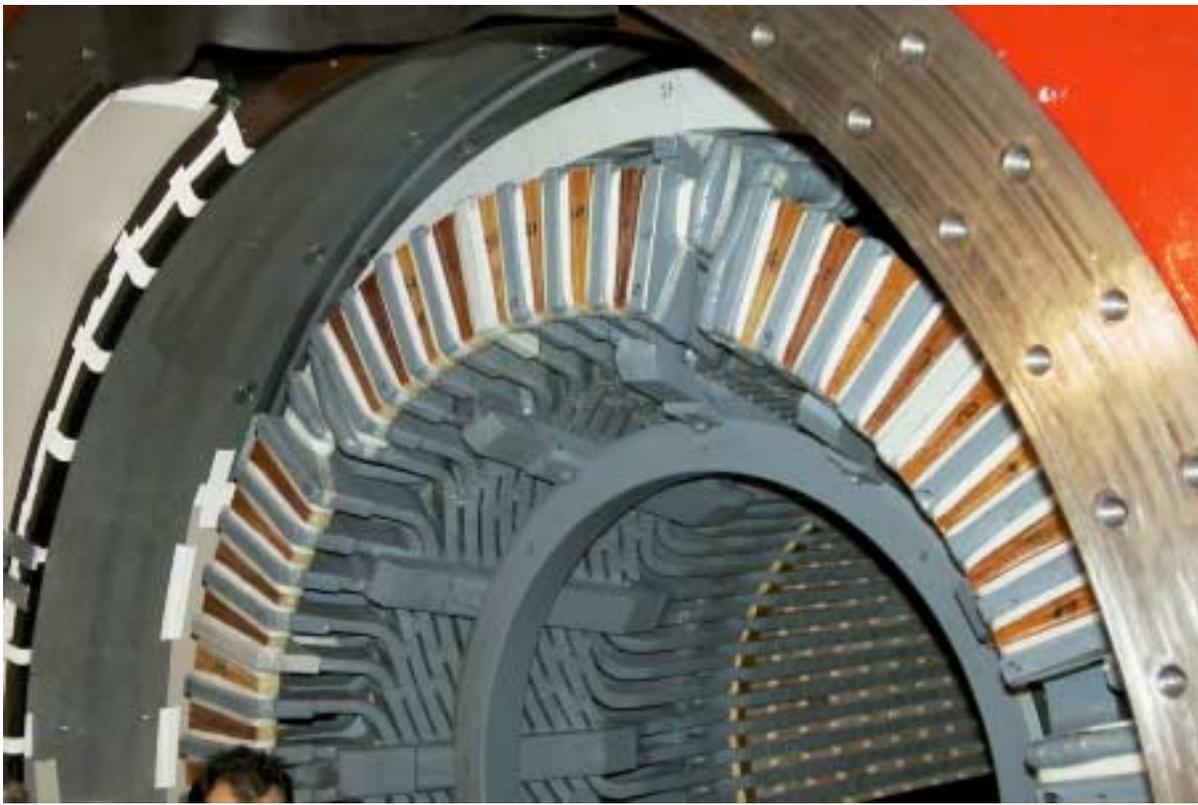
After these measurements and also several electrical tests made on one generator showed a good condition of the stator winding, a modification of the end-winding fixation was studied. By means of a tangential wedging and relative low expenditures, a reduction to acceptable values of the end-winding dynamic flexibility in tangential direction appeared possible as well as a shift of the four node mode resonance frequency. The tangential wedging of each end-winding would be linked to a rigid arch (Fig. 10).

*Fig. 10: Example of tangential wedging of end-winding*

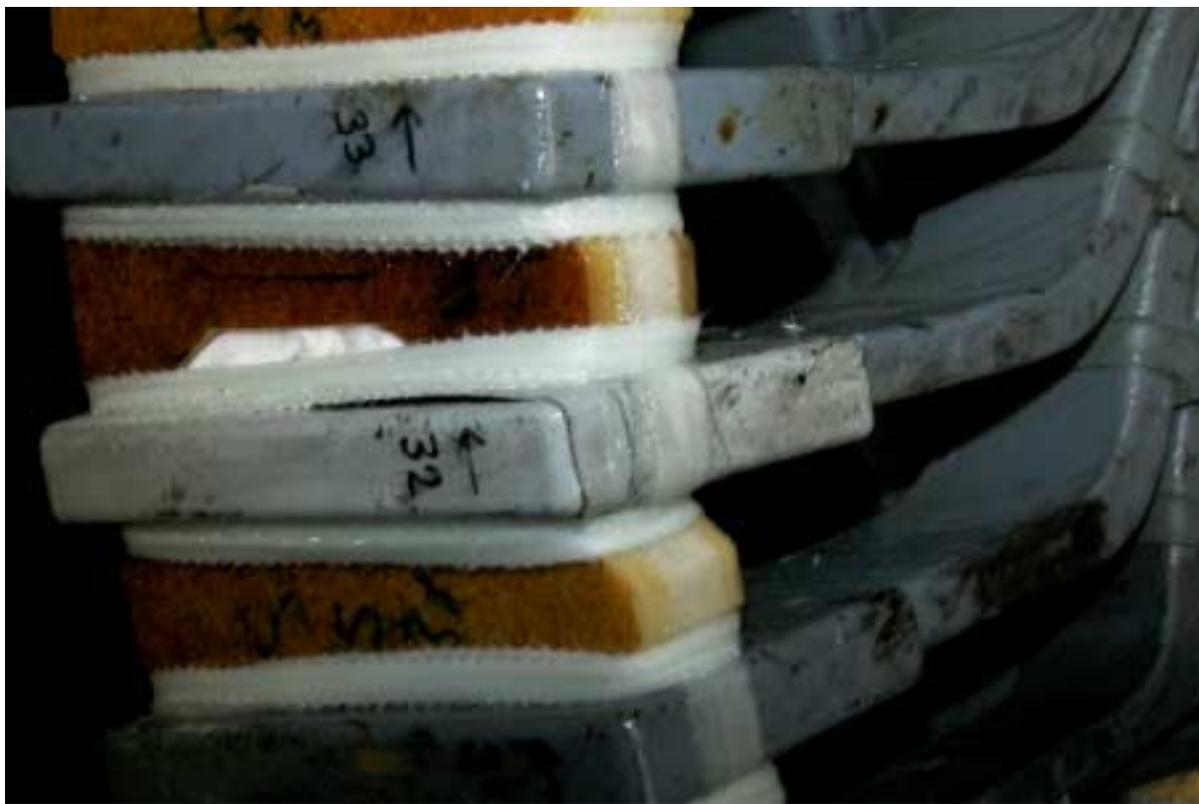
Fibre optic accelerometers with respective feedthrough conditioning units were first fitted to end-windings on generator TG11 and TG12 and later on generators TG21 and TG22. Since it was intended to wedge the end-windings in tangential axis, six accelerometers on each side of the generators were installed to measure radial vibration (Fig. 4). The accelerometers are located on stator bars with the longest non-supported axial length. In addition, at the driven end, an accelerometer was mounted at a phase separation to measure the tangential vibration (Fig. 11).

Fig. 11: Installed fibre optic accelerometer for tangential measurement

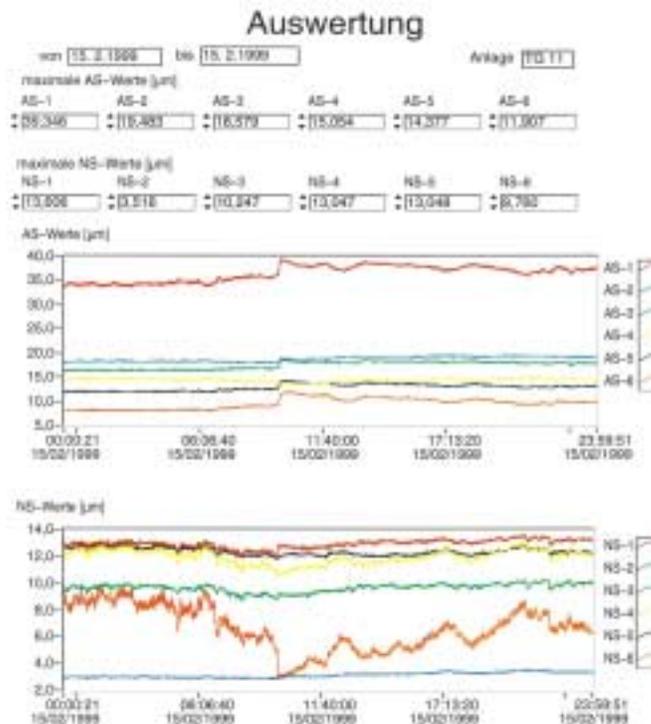
The measured vibration depend on current apparent power and on cooling gas temperature; therefore small changes of cooling gas temperature influence the vibration amplitudes. This depends on the fact that the operating resonance of the end-windings is more or less identical to the electrodynamic excitation force of 100 Hz. Figure 12 and 13 show the vibration behaviour of the end-windings during power changes and during cooler cleaning.

Fig. 12: Vibration behaviour of the end-windings during power changes

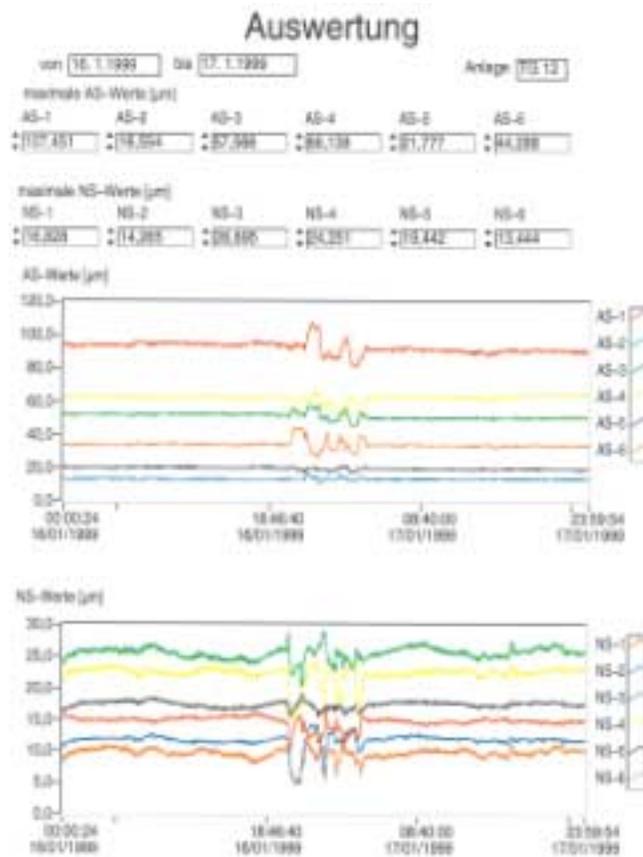
Fig. 13: Vibration behaviour of the end-windings during cooler cleaning

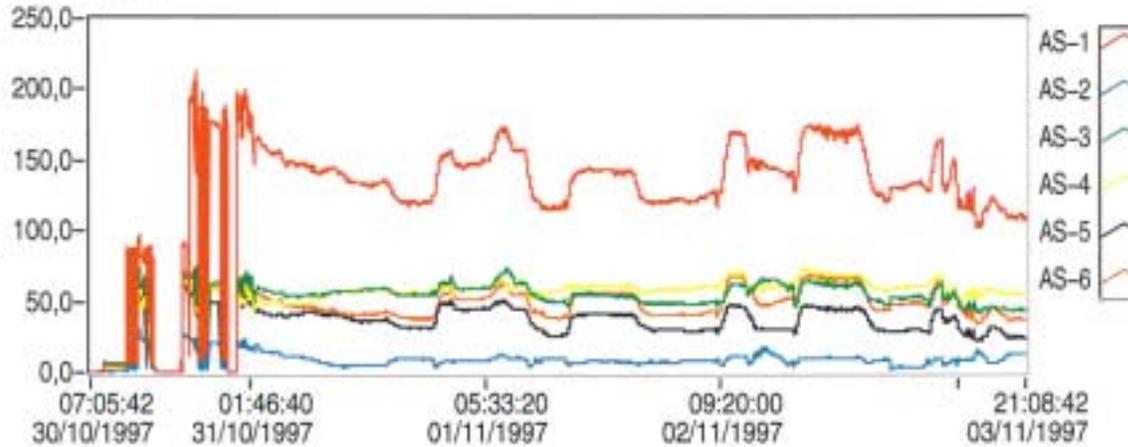
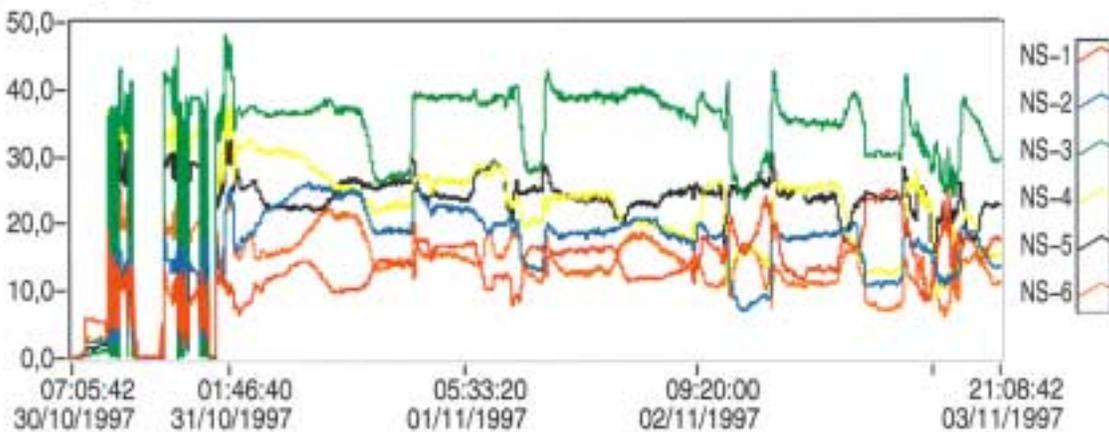
In fact, during start up the tangential vibration went down to 118 mm (Fig. 14 and Fig. 15) instead of 212 mm before the modifications, and to 75 mm in normal operation instead of 100 mm. The maximal value of radial vibration decreased from 30 mm to 20 mm. Despite a little increase of the radial vibration for some low level channels, the reduction was in average approximately 30%.

AS-Werte [ $\mu\text{m}$ ]

NS-Werte [ $\mu\text{m}$ ]

Fig. 14: Vibration behaviour of end-windings during startup before modifications

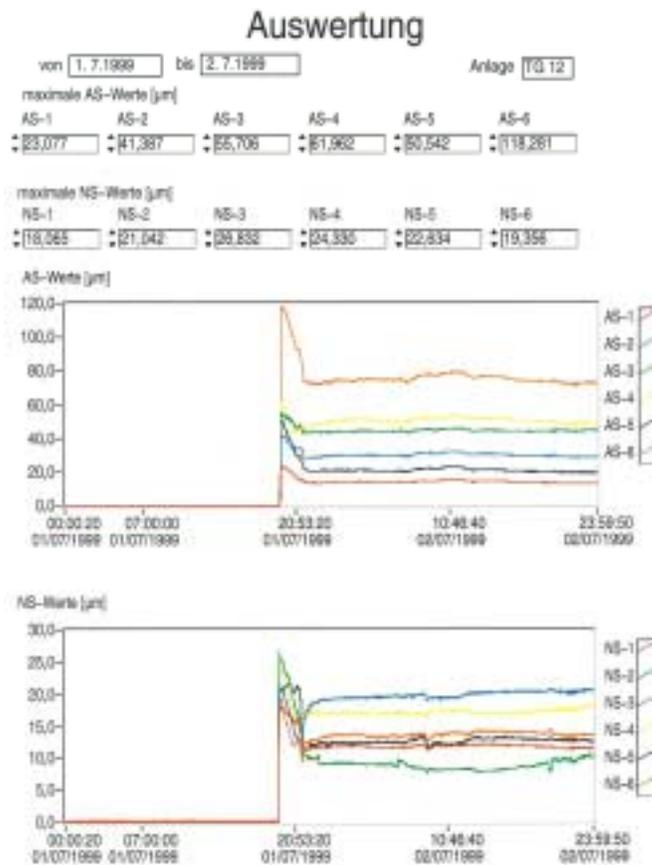
Fig. 15: Vibration behaviour of end-windings during start-up after modifications
