**Recent Developments in Large Generator Repair Solutions
and
Monitoring Systems**

**K. Weigelt
D. J. Graves
Generator & Motor Services, Inc.**

**EPRI – Generator Predictive Maintenance & Refurbishment
Conference
December 2, 1998**

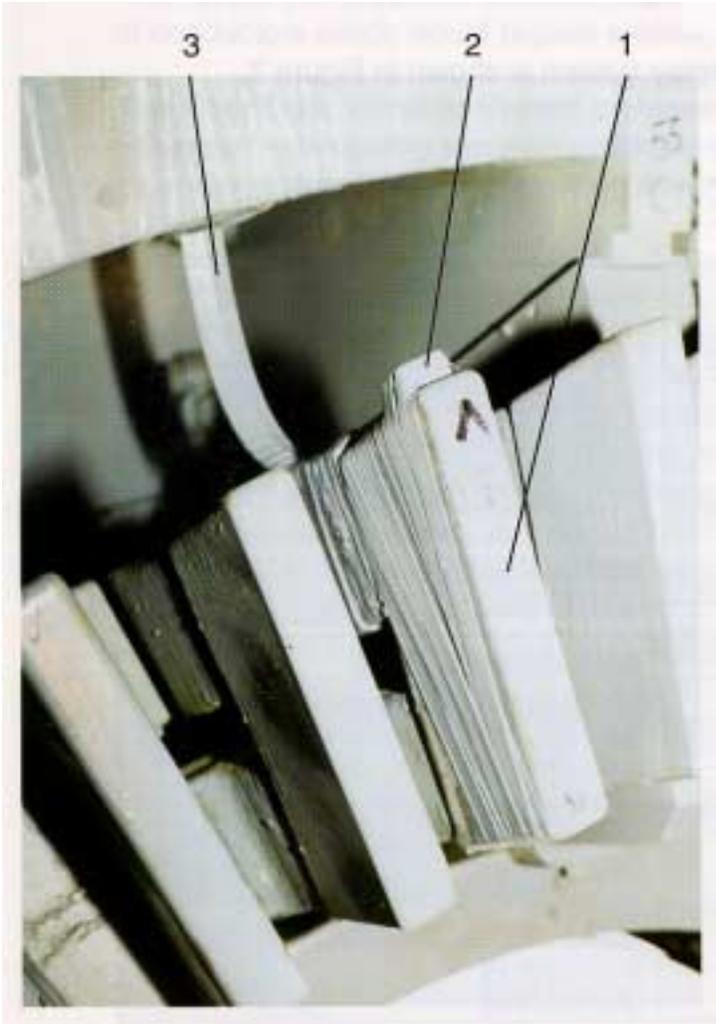
- 1) High Voltage Stator End-Winding
- 2) Installed Fiber Optic Sensor
- 3) Routing of the Fiber Optic Cable

Fig. 14: Installed fiber optic sensor.

Figure 14 shows a Fiber Optic Sensor installed on a high voltage stator end-winding.
